End State Condition Report for Materials and Fuels Complex Facilities MFC-799, 799A, and 770C

October 2010

This report documents completion of pre-transfer stabilization actions for buildings MFC-799, 799A, and 770C, as identified in Department of Energy Guide 430.1-5, "Transition Implementation Guide," and indicates that these facilities are ready for transfer from DOE-NE to the DOE Office of Environmental Management. The facilities are in a known, safe condition and information is provided to support efficient decommissioning and demolition planning, while minimizing the possibility of encountering unforeseen circumstances during the decommissioning and demolition activities.

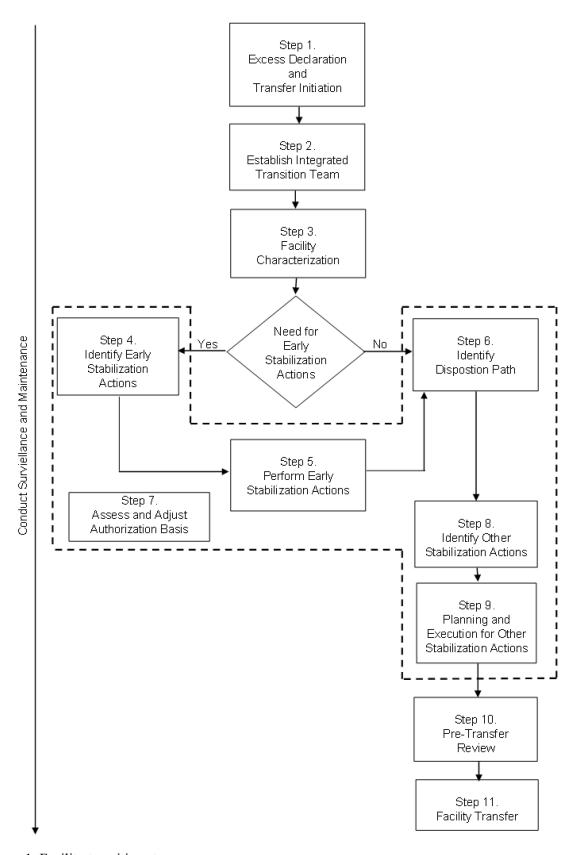
Figure 1. Facility transition steps.

DOE Guide 430.1-5 recommends an 11-step process that leads up to final facility transfer. This process is depicted in Figure 1.

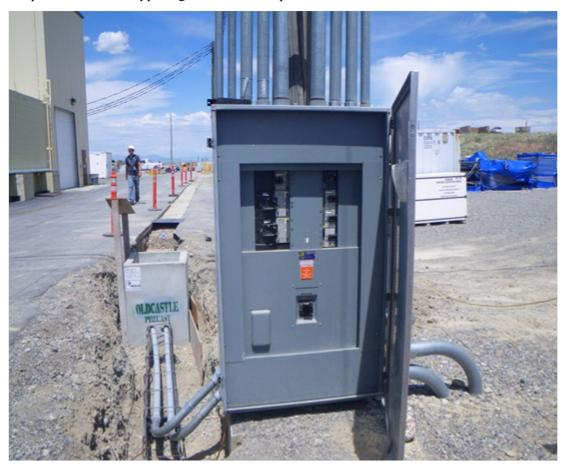
Figure 2. Electrical re-route for MFC-771.

The design resulted in replacing the original three-phase, 600-V power feed into the MFC-799 electrical control center with a new service that bypasses MFC-799 altogether. This bypass service feeds from a new 50-amp breaker in Power Panel 110 and transits north along the MFC roadway via a newly installed 250-ft underground ductbank, which ties back into the underground transition (ductbank to RGS buried cable) located on the north side of the Sodium Processing Facility. This new ductbank contains two conduit lines housing 600-V copper cable.

Figure 2 shows the nearly complete re-route. Power Panel 110 is in the foreground and the new feeder breaker is positioned in the upper right corner of the panel.

Additionally, two electrical handholes were installed at each end of the ductbank to accommodate the electrical tie-in, access, and drainage. Construction, installation, removal of previous portions of electrical system, continuity testing, and final facility turnover are complete and MFC nuclear operations has accepted the project.

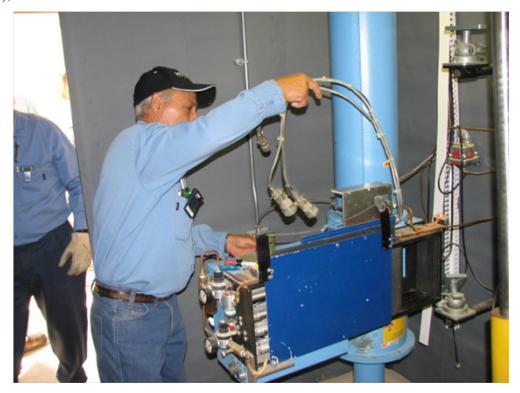
Figure 3. Disassembly of MFC-770C calibration source.

The forklift and charging system is being retained by NE and is being relocated to MFC-793. The hoists and cranes are excess to NE needs and have been abandoned in place. These will be transferred to EM with the facility. The beam calibrator and attenuator system have been removed and dispositioned (Figure 3), as discussed in Section 3.3.

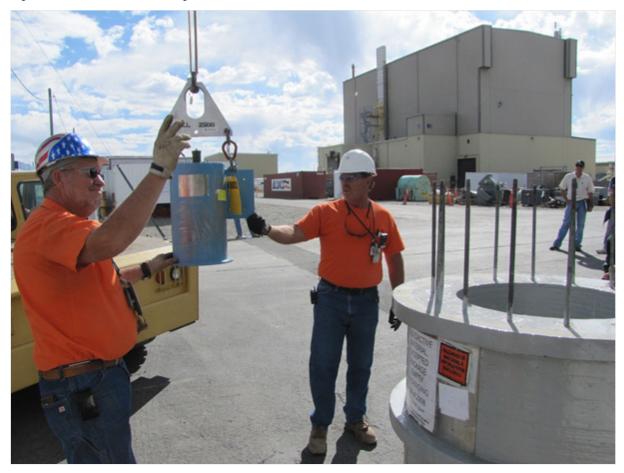
Figure 4. Loading source for shipment.

The source was packaged and shipped to the Nevada National Security Site (Figure 4) by JL Shepherd and Associates on September 15, 2010.

Outside shipping services were necessary to accommodate the 94 curie quantity of cesium and the Type 'B' package. A contract was established with JL Shepherd and Associates to perform the shipment of the Cs-137 source to Nevada National Security Site for disposal in the underground burial facility. Waste profile NEID-CHCS137SS was approved on Aug 20, 2010, in a letter titled "Approval to Ship Battelle Energy Alliance (BEA) Low-Level Radioactive Waste to the Nevada Test Site (NTS)." A copy of the letter and the associated Integrated Waste Tracking System ship task are included as Appendix C.

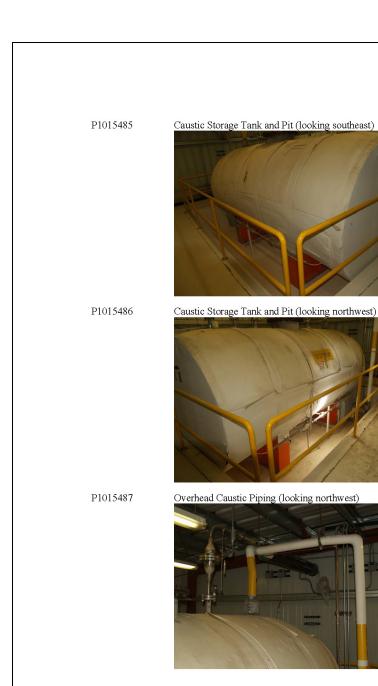
Caustic Storage Tank and Pit (looking southwest)

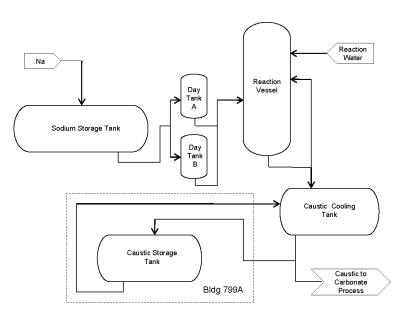
Figure 1. Simplified process flow diagram.

Residual hazardous materials are confined to the system process components depicted in the simplified process flow diagram in Figure 1. The Facilities Condition and Hazards Assessment (INL 2009) provides a detailed description of the MFC-799/799A equipment and process from which the following summary is extracted.

The Sodium Process Equipment Area was used to store and treat alkali metal hazardous waste/mixed waste. There are several major components in the sodium process area, including a 5,000-gal sodium storage tank, two 730-gal sodium day tanks (Tank A on the west side and Tank B on the east), sodium reaction vessel, 1,000-gal caustic cooling tank, and a 4,000-gal caustic storage tank.
